# VERIFYING MICROVOID ELIMINATION AND PREVENTION VIA AN OPTIMIZED IMMERSION SILVER PROCESS

John Swanson and Donald Cullen  
MacDermid, Inc.  
Waterbury, CT USA

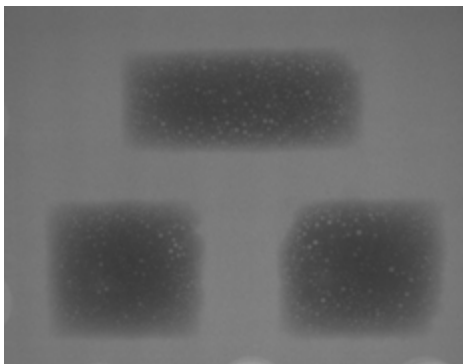
**Figure 1**  
X-ray View of Microvoiding in Soldered Pads

There are at least three basic techniques for identifying and measuring microvoids. Each has their own strengths and weaknesses. One technique involves the physical “prying” of components from an assembly, with subsequent visual inspection of the pad after prying. This technique has obvious shortcomings, one of which involves poor reproducibility associated with variability in prying. Another technique involves the use of X-ray inspection. Figure 1 shows an example of voiding as observed in soldered pads joint via X-ray equipment. With this technique, an assembled solderjoint can be non-destructively observed. On a negative side, there may be doubt as to whether a void exists within the bulk solder or at the copper interface. Additionally, X-ray equipment is costly and not present in many fabrication and assembly facilities. The second technique for identifying microvoids involves relatively simple cross sectioning. Figure 2 shows voiding observed in a BGA pad via cross-sectioning. It will be obvious to most that this technique is destructive, but also relatively simple and commonly employed. Lastly, it should be noted that the X-ray technique allows inspection of an entire pad surface, whereas the cross-section observations are limited to a “slice” of a given pad.

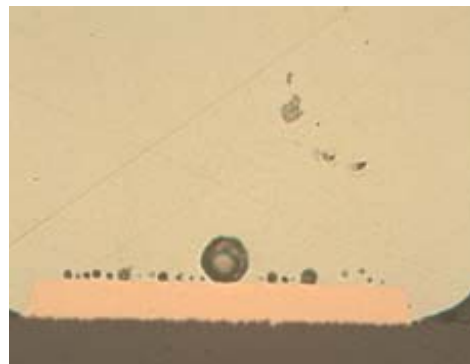
**Figure 2**  
Cross-section View of BGA Microvoiding

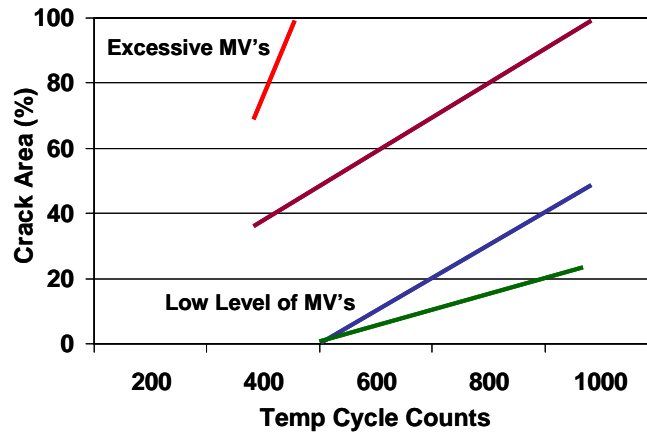
Recent studies and publications have shown that high densities of microvoids in solder joints do not affect assembly yields, but do present significant reliability risk. The key mechanism by which this risk is manifested is illustrated in figure 3. When subjected to the rigors of temperature cycling, assemblies exhibiting significant voiding failed via excessive crack

propagation whereas those with little to no voiding did not. The key issue here is that the presence of microvoids enables the more rapid travel of cracks through the joint interface, resulting in electrical failure<sup>6,7</sup>.

Figure 3: Effect of Microvoid Density on Temp Cycle Performance<sup>6,7</sup>

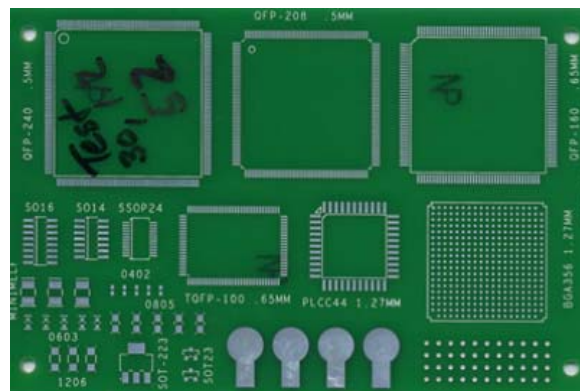
Throughout most of this work, a standard test vehicle was utilized to study microvoid phenomena. This vehicle could be conveniently used in both laboratory and production settings, and included a standard BGA component pattern with a squared configuration of pads (see figure 4). Cross sectioning and inspection for microvoiding was conducted across a row of these pads. Our standard procedure called for 16 pads to be analyzed across a cross-sectioned row.

Figure 4: Standard Test Vehicle with BGA Feature

Our initial field verification involved producing our standard test vehicle described in Figure 4 earlier at a high volume fabricator utilizing a peroxide based etch and old operating conditions (higher silver levels and lower temperature). This particular fabricator was also chosen because it utilized a second immersion silver chemistry from a process claimed to be intrinsically resistant to microvoid formation (referred to as “Process A” earlier in this paper)<sup>10</sup>. For this work, we started by running test boards with our control process. We then progressively altered three key variables (etch type, silver concentration, and plating temperature to assure deposit quality), sampling test boards as each process modification was made. Finally, we produced boards from immersion silver “process A” per standard operating practice for inclusion in our evaluation. The silver thickness was held constant at approximately 0.25 microns throughout this testing (accomplished by altering immersion plating time) and subsequent microvoid analysis was conducted via cross-section technique as described earlier. A total of 5 test boards were run per condition, giving 80 individual void observations per condition (5 x 16 pads per board). The results from this work are displayed below in figure 14. While all microvoid results were relatively low and acceptable by most standards, it can clearly be seen that our key process modifications produced a statistically significant improvement in microvoid performance. This important result cleared the way for a modification of our best practice process recommendations for our customers.

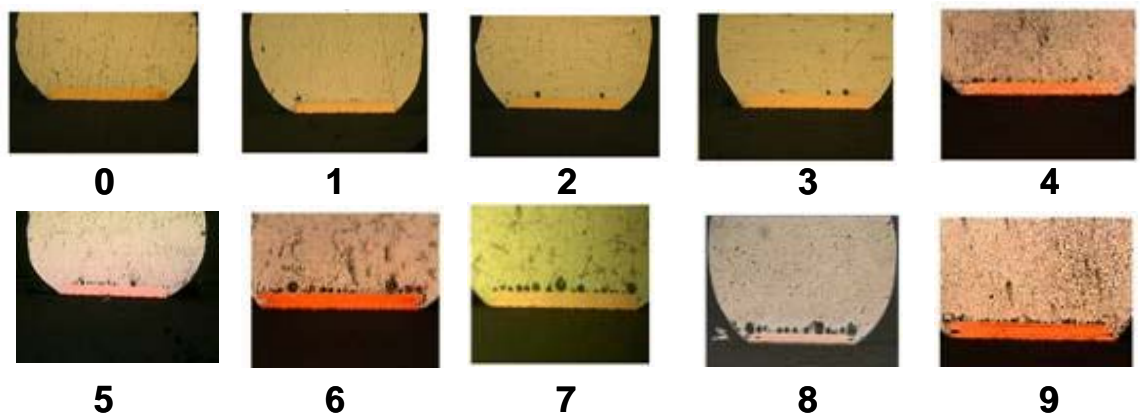
Microvoid levels were then quantified and plotted utilizing the illustrative scale shown below in figure 5. This ranking system was scaled from zero to nine, where zero indicated an essentially void-free interface and 9 equated to near complete coverage of the pad.

Figure 5: Scale Used to Rank Microvoid Severity

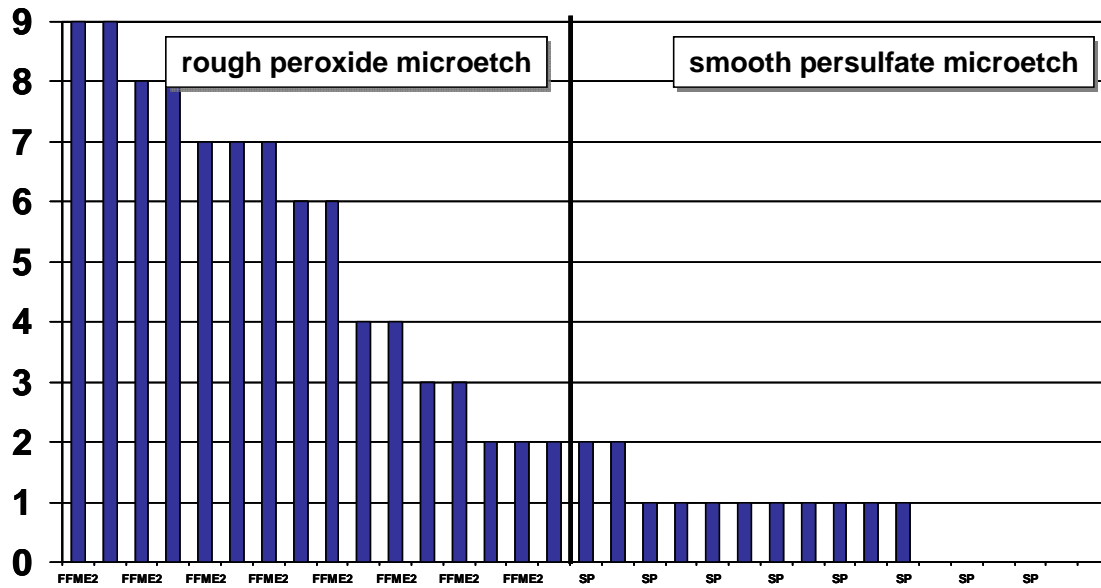
Figure 6 shows the results of a key study which involved the manipulation of several process variables, including microetch type. For this work, we prepared samples utilizing two commonly used microetches: an acidic peroxide based chemistry known to produce a more rough topography and a proprietary acidic persulfate based chemistry which delivers a smoother topography. Silver thickness was maintained at 0.25 microns. As figure 6 shows, samples processed through the persulfate based etch exhibited negligible microvoid levels; whereas those processed through the peroxide chemistry consistently produced significant voiding. This plot simply displays a sorted view of microvoid intensity, with microetch type highlighted; other influential factors are discussed later.

**Figure 6: Microvoid Results from One Study, Sorted by Severity and Microetch Type**

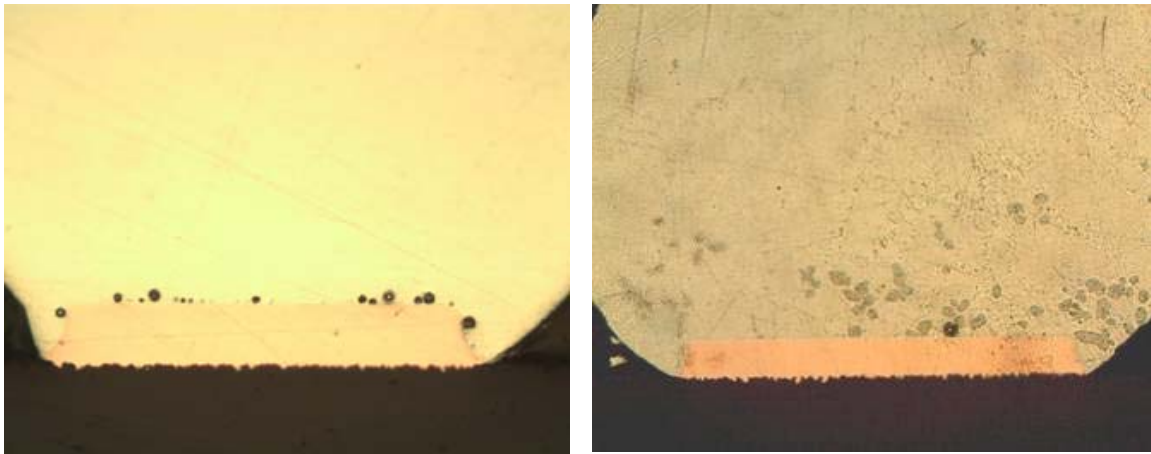
In an effort to further validate this important effect, we chose to investigate the role of the rough topography microetch on a silver coating deposited from an alternative immersion silver chemistry claimed to be intrinsically resistant to microvoid formation, referred to as “Process A”<sup>10</sup>. Figure 7 below illustrates typical void levels from deposits processed through peroxide and modified persulfate based etches respectively. Again, all silver thicknesses were maintained at 0.25 microns. These results clearly support the claim that basic peroxide microetches commonly used in PCB fabrication sites (these etches do not typically contain additives which impart a polished surface) strongly induce and enable microvoid formation, independent of the silver plating chemistry employed.

**Figure 7: Microvoids produced from “Process A” utilizing peroxide and persulfate etches**

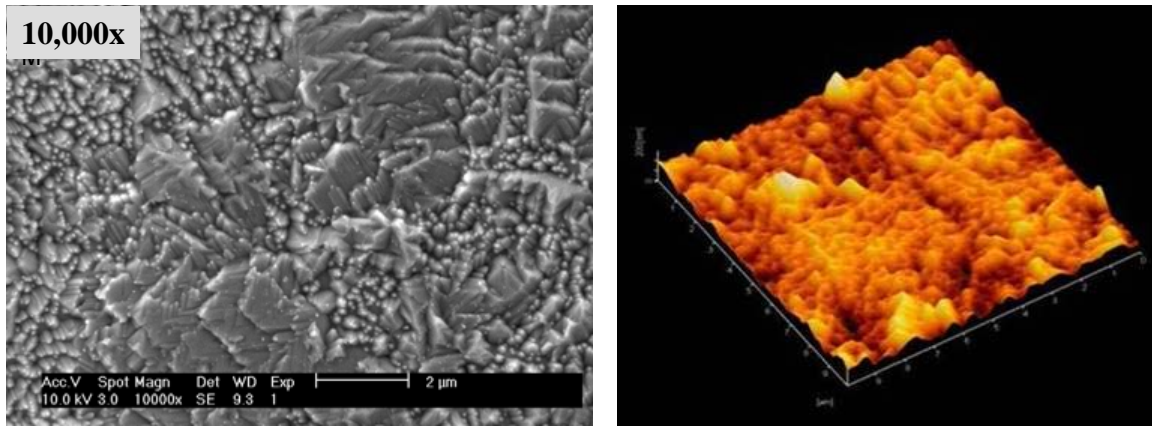
The strong effect observed via microetch naturally led to a question of what may be the cause of the phenomena. A close look at the surface topography of copper provided some clues. Figures 8 and 9 show SEM and Atomic Force Microscope (AFM) images of copper surfaces processed

through each respective etch. A clear difference in structure is observed. One explanation offers that structural features produced by widely used peroxide treatments may result in highly active sites and localized non-uniform silver deposition in this area.

**Figure 8: Structure of Peroxide Etched Copper by SEM and AFM**

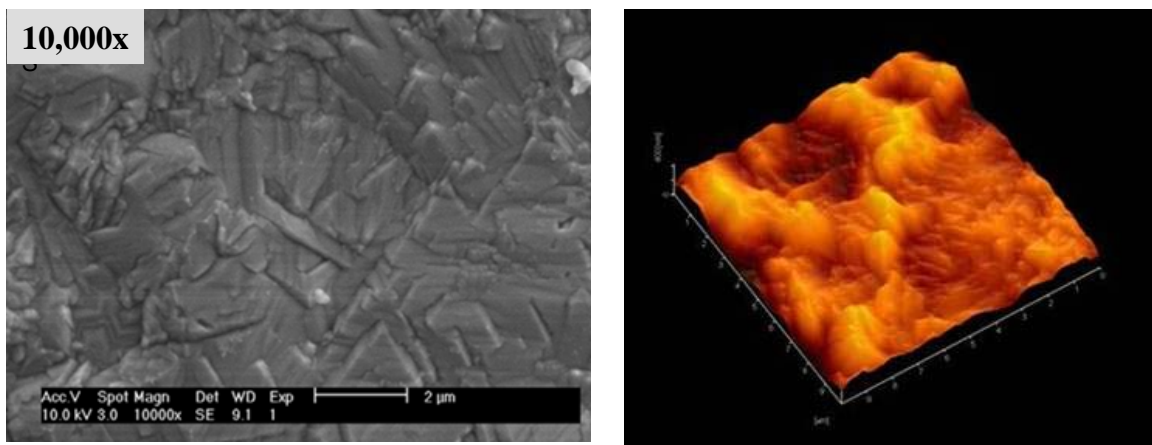
**Figure 9: Structure of Persulfate Based Etched Copper by SEM and AFM**

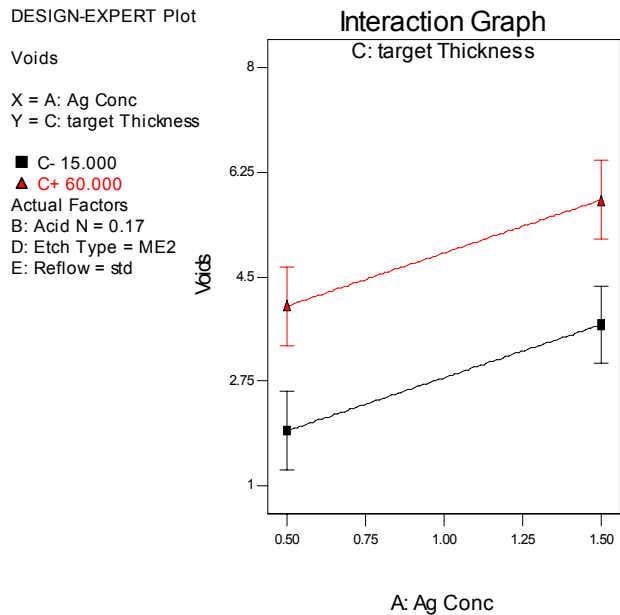
Additional studies identified the rate of the immersion silver plating reaction to also be influential on the formation of microvoids. Figure 10 below shows output from a full factorial DOE which included silver concentration as a factor in the formation of microvoids. In this testing, two silver thicknesses were examined, 0.37 and 1.5 microns. Though not as dramatic as the microetch effect, the result is clear and statistically valid.

**Figure 10: Effect of Silver Content and Silver Thickness on Microvoiding**

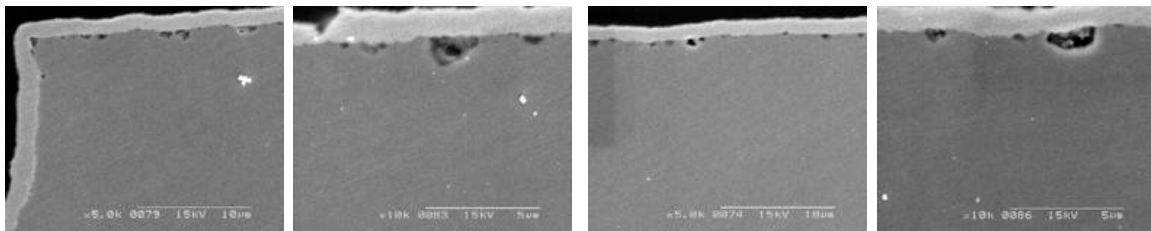
A combination of internal work and discussion/cooperation with others studying the microvoid phenomena led us to more detailed investigation aimed at better defining a mechanism for microvoid formation<sup>7</sup>. The enabling effects of peroxide etch and higher silver concentrations were repeatable in a lab environment, but these results did not offer a mechanism for void formation. A very important finding involved the identification of “caves” underneath the plated silver surface in samples which subsequently exhibited void formation. Figures 11 and 12 exhibit images of cross-sectioned, silver plated test vehicles. Images shown in figure 11 were processed through conditions which promote microvoid formation (peroxide microetch and higher silver concentration). The cavities/vacancies observed underneath the plated silver have come to be commonly referred to as “caves”; they could be consistently produced by processing materials through the “enabling” conditions discussed above. Figure 12 shows few to no caves; these images were processed under conditions which promote a microvoid-free assembly (persulfate etch and lower silver concentration). These samples consistently yielded microvoid-free solderjoints/assemblies.

**Figure 11: Caves Produced Under Silver Coating Processed Through Peroxide Microetch**

With the identification of the caving phenomena, a better mechanistic explanation for microvoiding is feasible. Images of caving are best seen via advanced tools such as Focused Ion Beam (FIB), but adequate analysis can also be obtained through careful and skilled traditional metallographic techniques (polishing).

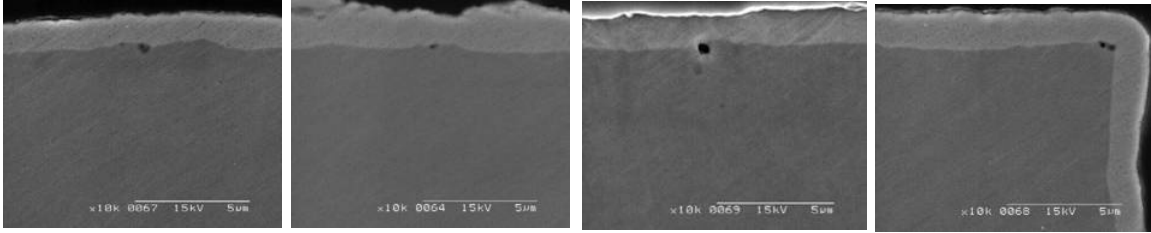
**Figure 12: Caves Produced Under Silver Coating Processed Through Persulfate Microetch**

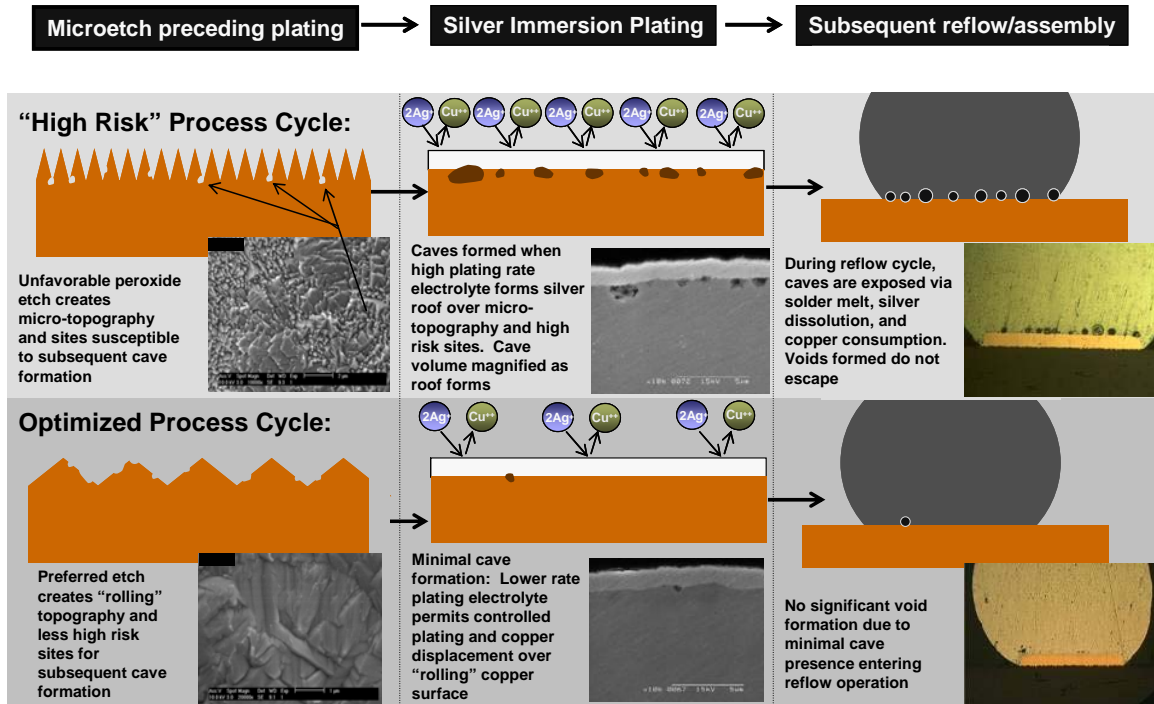
Summarizing the work above, we propose the following as an explanation of the microvoid mechanism: The surface condition and topography of the copper as it enters into the silver plating step plays a critical role in the potential formation of caves, which eventually manifest as microvoids in the assembly/reflow operation. The topography created by the peroxide etch provides sites that are susceptible to cave formation in the plating step. This “susceptibility” to cave and microvoid formation may be enhanced if the copper is not effectively cleaned. Soldermask residues and scums may provide a seeding site for localized cave formation (copper corrosion) in the plating step. Furthermore, the driving force of the immersion silver reaction, when excessive, can result in hyper-corrosion at active sites on the copper surface, resulting in cave formation and silver bridging across the cave. An illustration of our proposed microvoid mechanism is shown in figure 13.

**Figure 13: Illustration of Proposed Microvoid Mechanism**

Supplementing the mechanism proposed above, a key proposal is that the cave itself is leads to the formation of a microvoid. This may occur due the inability of entrapped air/gas to escape the

molten solder. It may also be linked to the formation of water vapor through the reaction of hot solder flux with copper oxides on the walls of the cave.

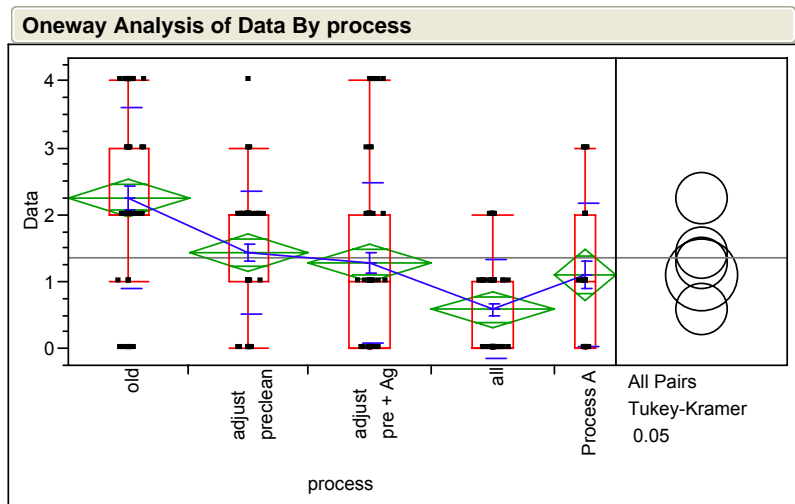
**Figure 14: Microvoid Results and Statistical Analysis of Production Implementation of New MacDermid Operating Parameters and Comparison to “Process A”**

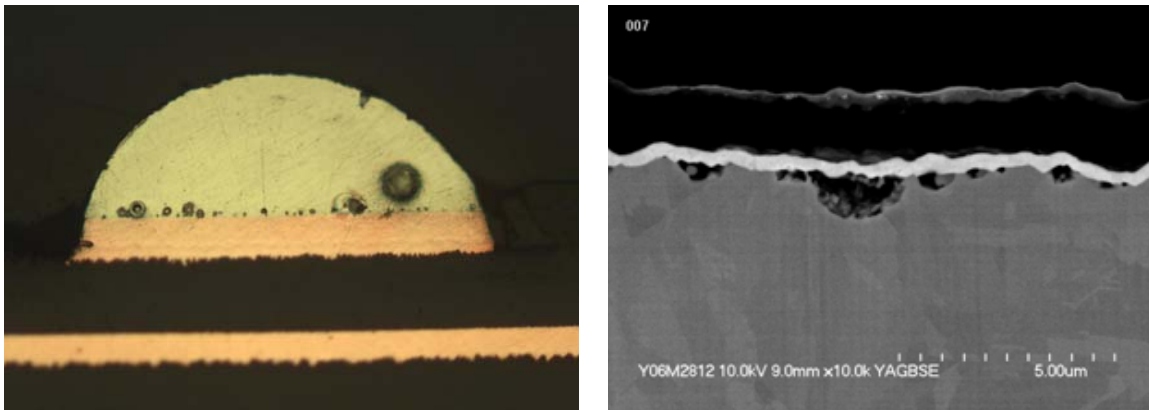
One strong example of this point is illustrated by an occurrence of microvoiding that we encountered early in 2006. This incident involved a fabrication site which suddenly experienced significant microvoiding; they had not yet converted to best practice operating conditions, but had been running problem free for an extended time. Upon converting to best practice conditions, the microvoiding disappeared permanently. Images of cave formation (via FIB) and microvoiding from past operating practices and new best practice conditions are shown below in Figures 16 and 17.

Figure 16: Microvoids and Caves (FIB analysis) Produced Under Old Operating Conditions

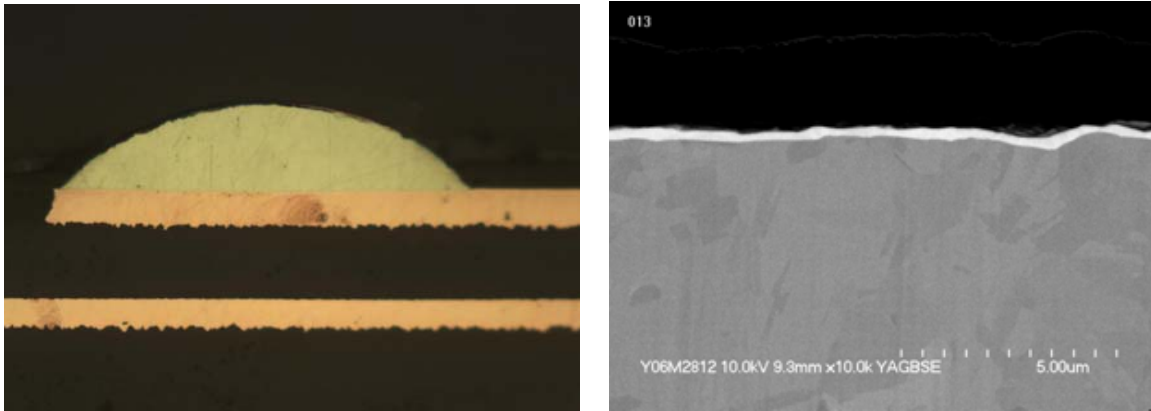
**Figure 17: Microvoid-free and Cave-free Samples Produced With New Best Practice Conditions**

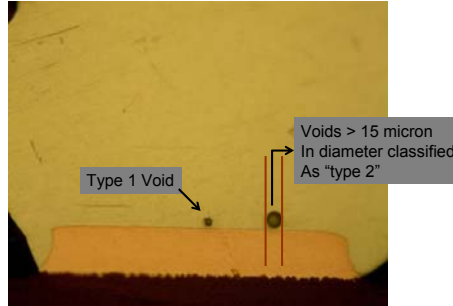
- Microvoids are classified as “type 1” and “type 2” as denoted by void size. “Type 1” voids are smaller than 15 microns in diameter. “Type 2” voids are larger than 15 microns (see Figure 18). All voids which are observed at the copper interface are considered to be microvoids.

**Figure 18: Illustration of Type 1 and Type 2 Microvoids**

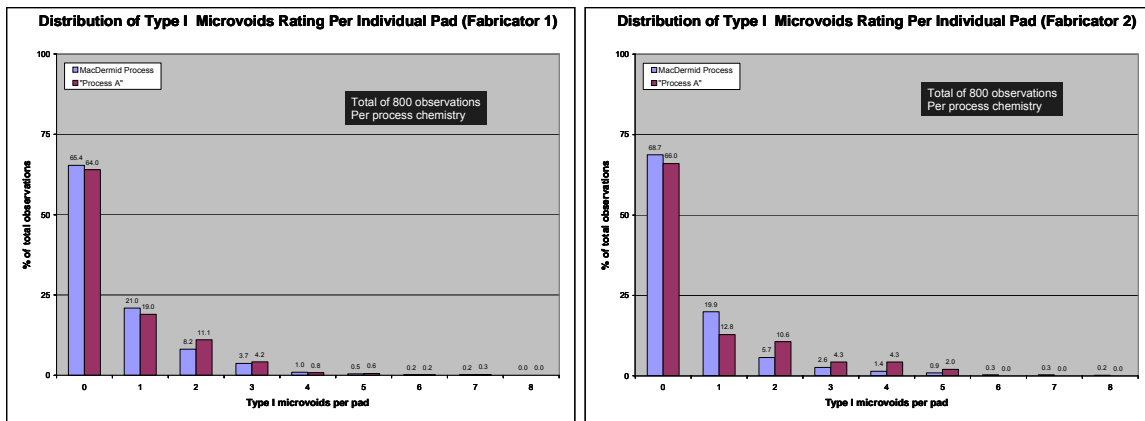
The results of the work conducted at the two fabrication sites are presented in figures 19 through 21 below. This rigorous pad by pad analysis at multiple fabrication sites clearly indicates that our Sterling™ Silver Best Practice consistently delivers a silver coating with minimal microvoid risk. This data also indicates the that the two chemistries evaluated exhibit no significant difference in microvoid propensity.

**Figure 21: Type 1 Void Distribution From 2 Process Chemistries at 2 Fabricators**

- Microvoid responses are graphed in two ways: First, the distribution of type 1 void observations per pad is plotted. This allows even a single outlying bad joint to be identified. It also allows for trends in void propensity to be more easily seen. The second method for plotting microvoids involves plotting void occurrence for a set of pads on a given board. We report results which normalize the void data to an eight pad set (1/2 of the pads analyzed on our test vehicle). This provides an analysis which is capable of identifying individual board samples with moderate to high “pockets” of microvoids. These plots include references to upper limits for void occurrence (the limits represent the opinion of assembly experts with which we have worked).

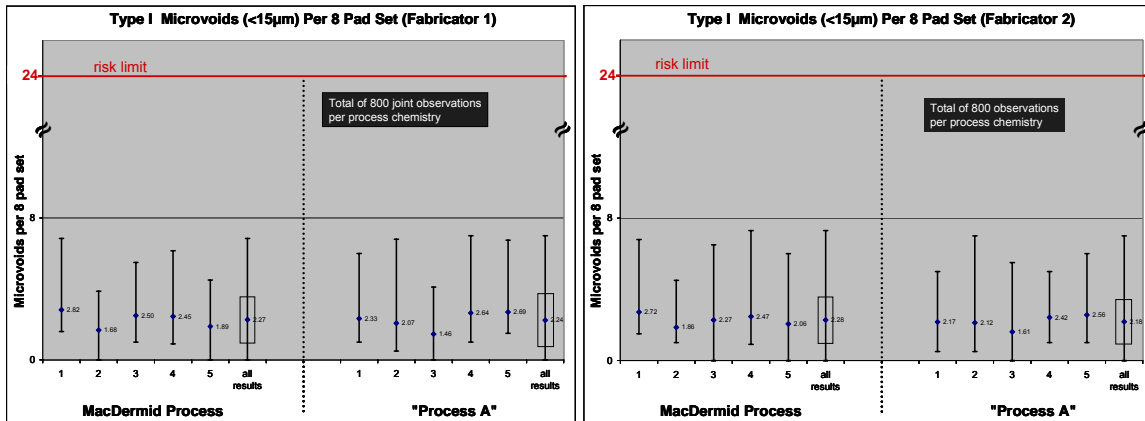
Figure 19: Type 1 Microvoid Occurrence From 2 Process Chemistries at 2 Fabricators

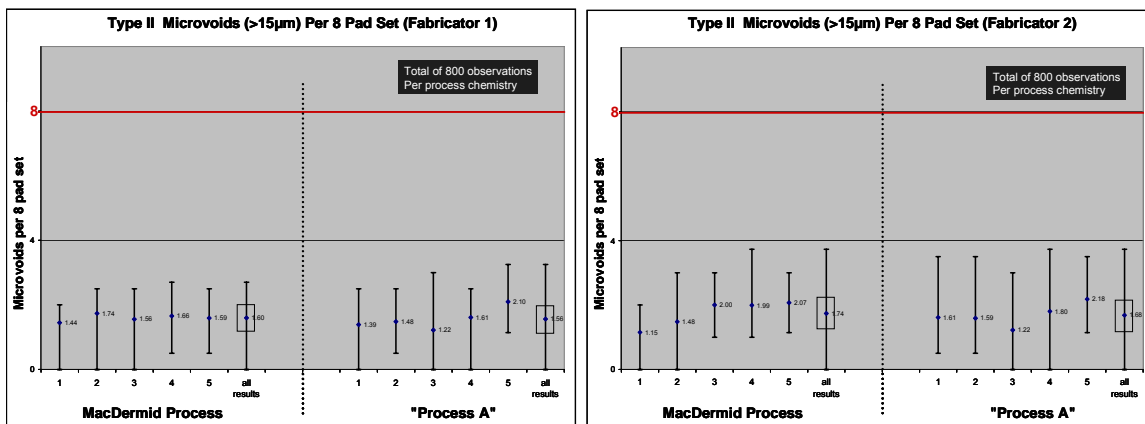
Figure 20: Type 2 Microvoid Occurrence From 2 Process Chemistries at 2 Fabricators
